Demonstrating ESTs for Building
waste Reduction in Indonesia

The DEBRI Project

Report on Tsunami-generated Debris September 2007

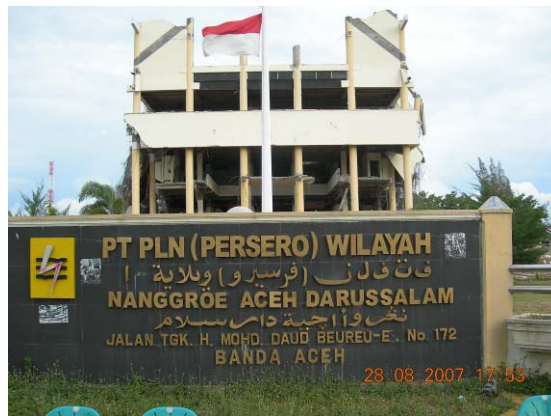
Figure 1. Remains of PLN Building under demolition (28 August 2007)

- Until July 2007, the number of tsunami/earthquake buildings demolished were 101 units (UNDP 2007). Since August 2006, the number of building demolished is less than 10 units. It is likely that no more building will be demolished by UNDP or DKP. Last important buildings to be demolished were PDAM elevated reservoir and PLN Regional Office buildings (August 2007). The PLN building demolition was carried out by independent contractor under PLN supervision.

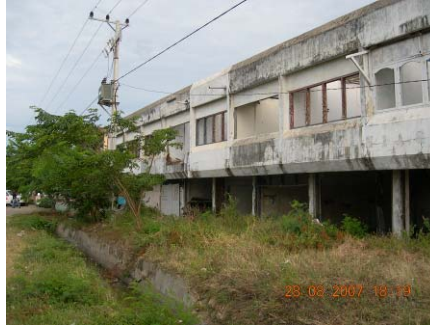
a. Two storied commercial establishment at Meuraxa

Figure 3. Tsunamis destroyed buildings still remains intact. Some of them (middle) are inhabited illegally.

- About 12 double storied commercial buildings at Meuraxa, Ulee lhee (near a tsunamis survival mosque), and 100-120 buildings (around 30 buildings are two storied commercial buildings) at Pasar Aceh, commercial buildings near Grand Mosque Baiturrahman, Kutaraja), and housing/residential buildings in Kuta Alam.

- Rapid risk assessment on the tsunami debris recommended that remains of destroyed buildings must be demolished as soon as possible to avoid further complicated problems. The main concern was the safety of the people who inhabited or lived near the building.

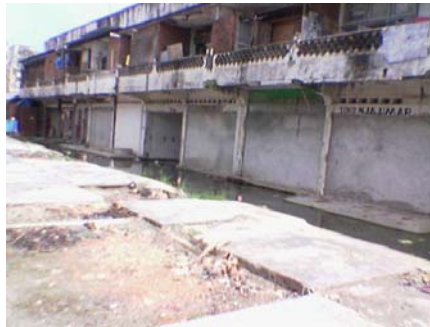
b. Commercial establishment near Pasar Aceh

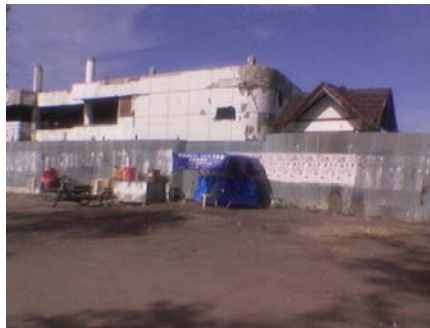
c. Commercial building at Kutaraja, next to Grand

Mosque

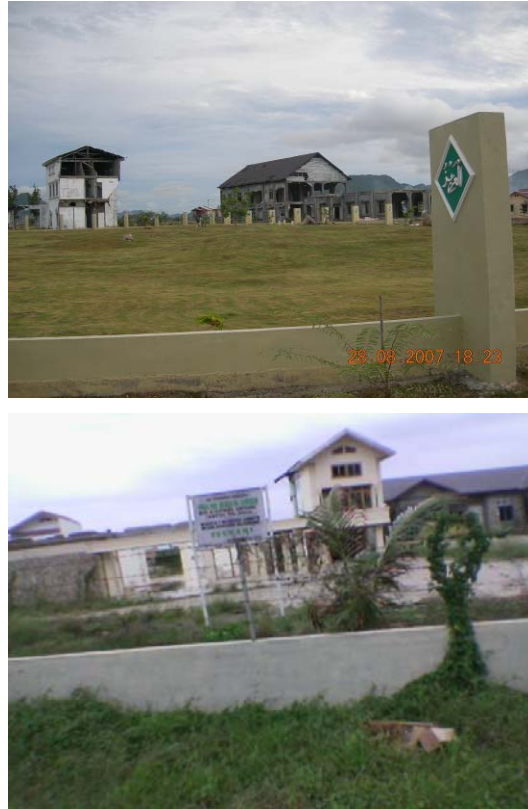
Figure 4. Destroyed buildings that are being kept intact as a memorial (as monuments). Top: buildings in a mass cemetery in Meuraxa, and above, the house that had been used to take amateur videos during the tsunami moment (Meuraxa).

- There are also some destroyed buildings that are being kept intact, as a “reminder” (monuments), such as in mass cemeteries (Meuraxa), and a two-stories building that was used to take videos of the tsunami moment.

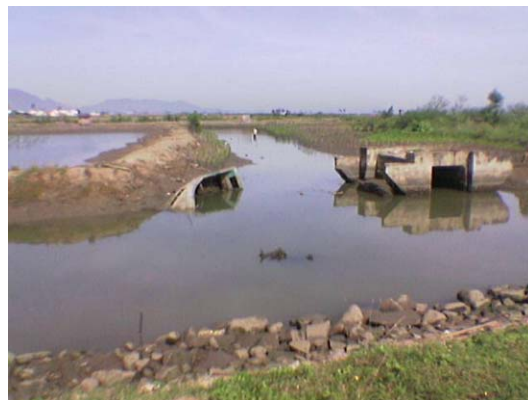
Figure 5. Remain of a destroyed bridge at Syah Kuala

- Bridge foundations in adjacent area of Syah Kuala
